Appendix E
Post-ROD XRF Surveying Results for Lead Contamination

XRF Survey of WAG 4

4. Title: X-Ray Fluorescence Survey of CFA-010 Transformer Yard for Lead (Pb) in Surface Soil.

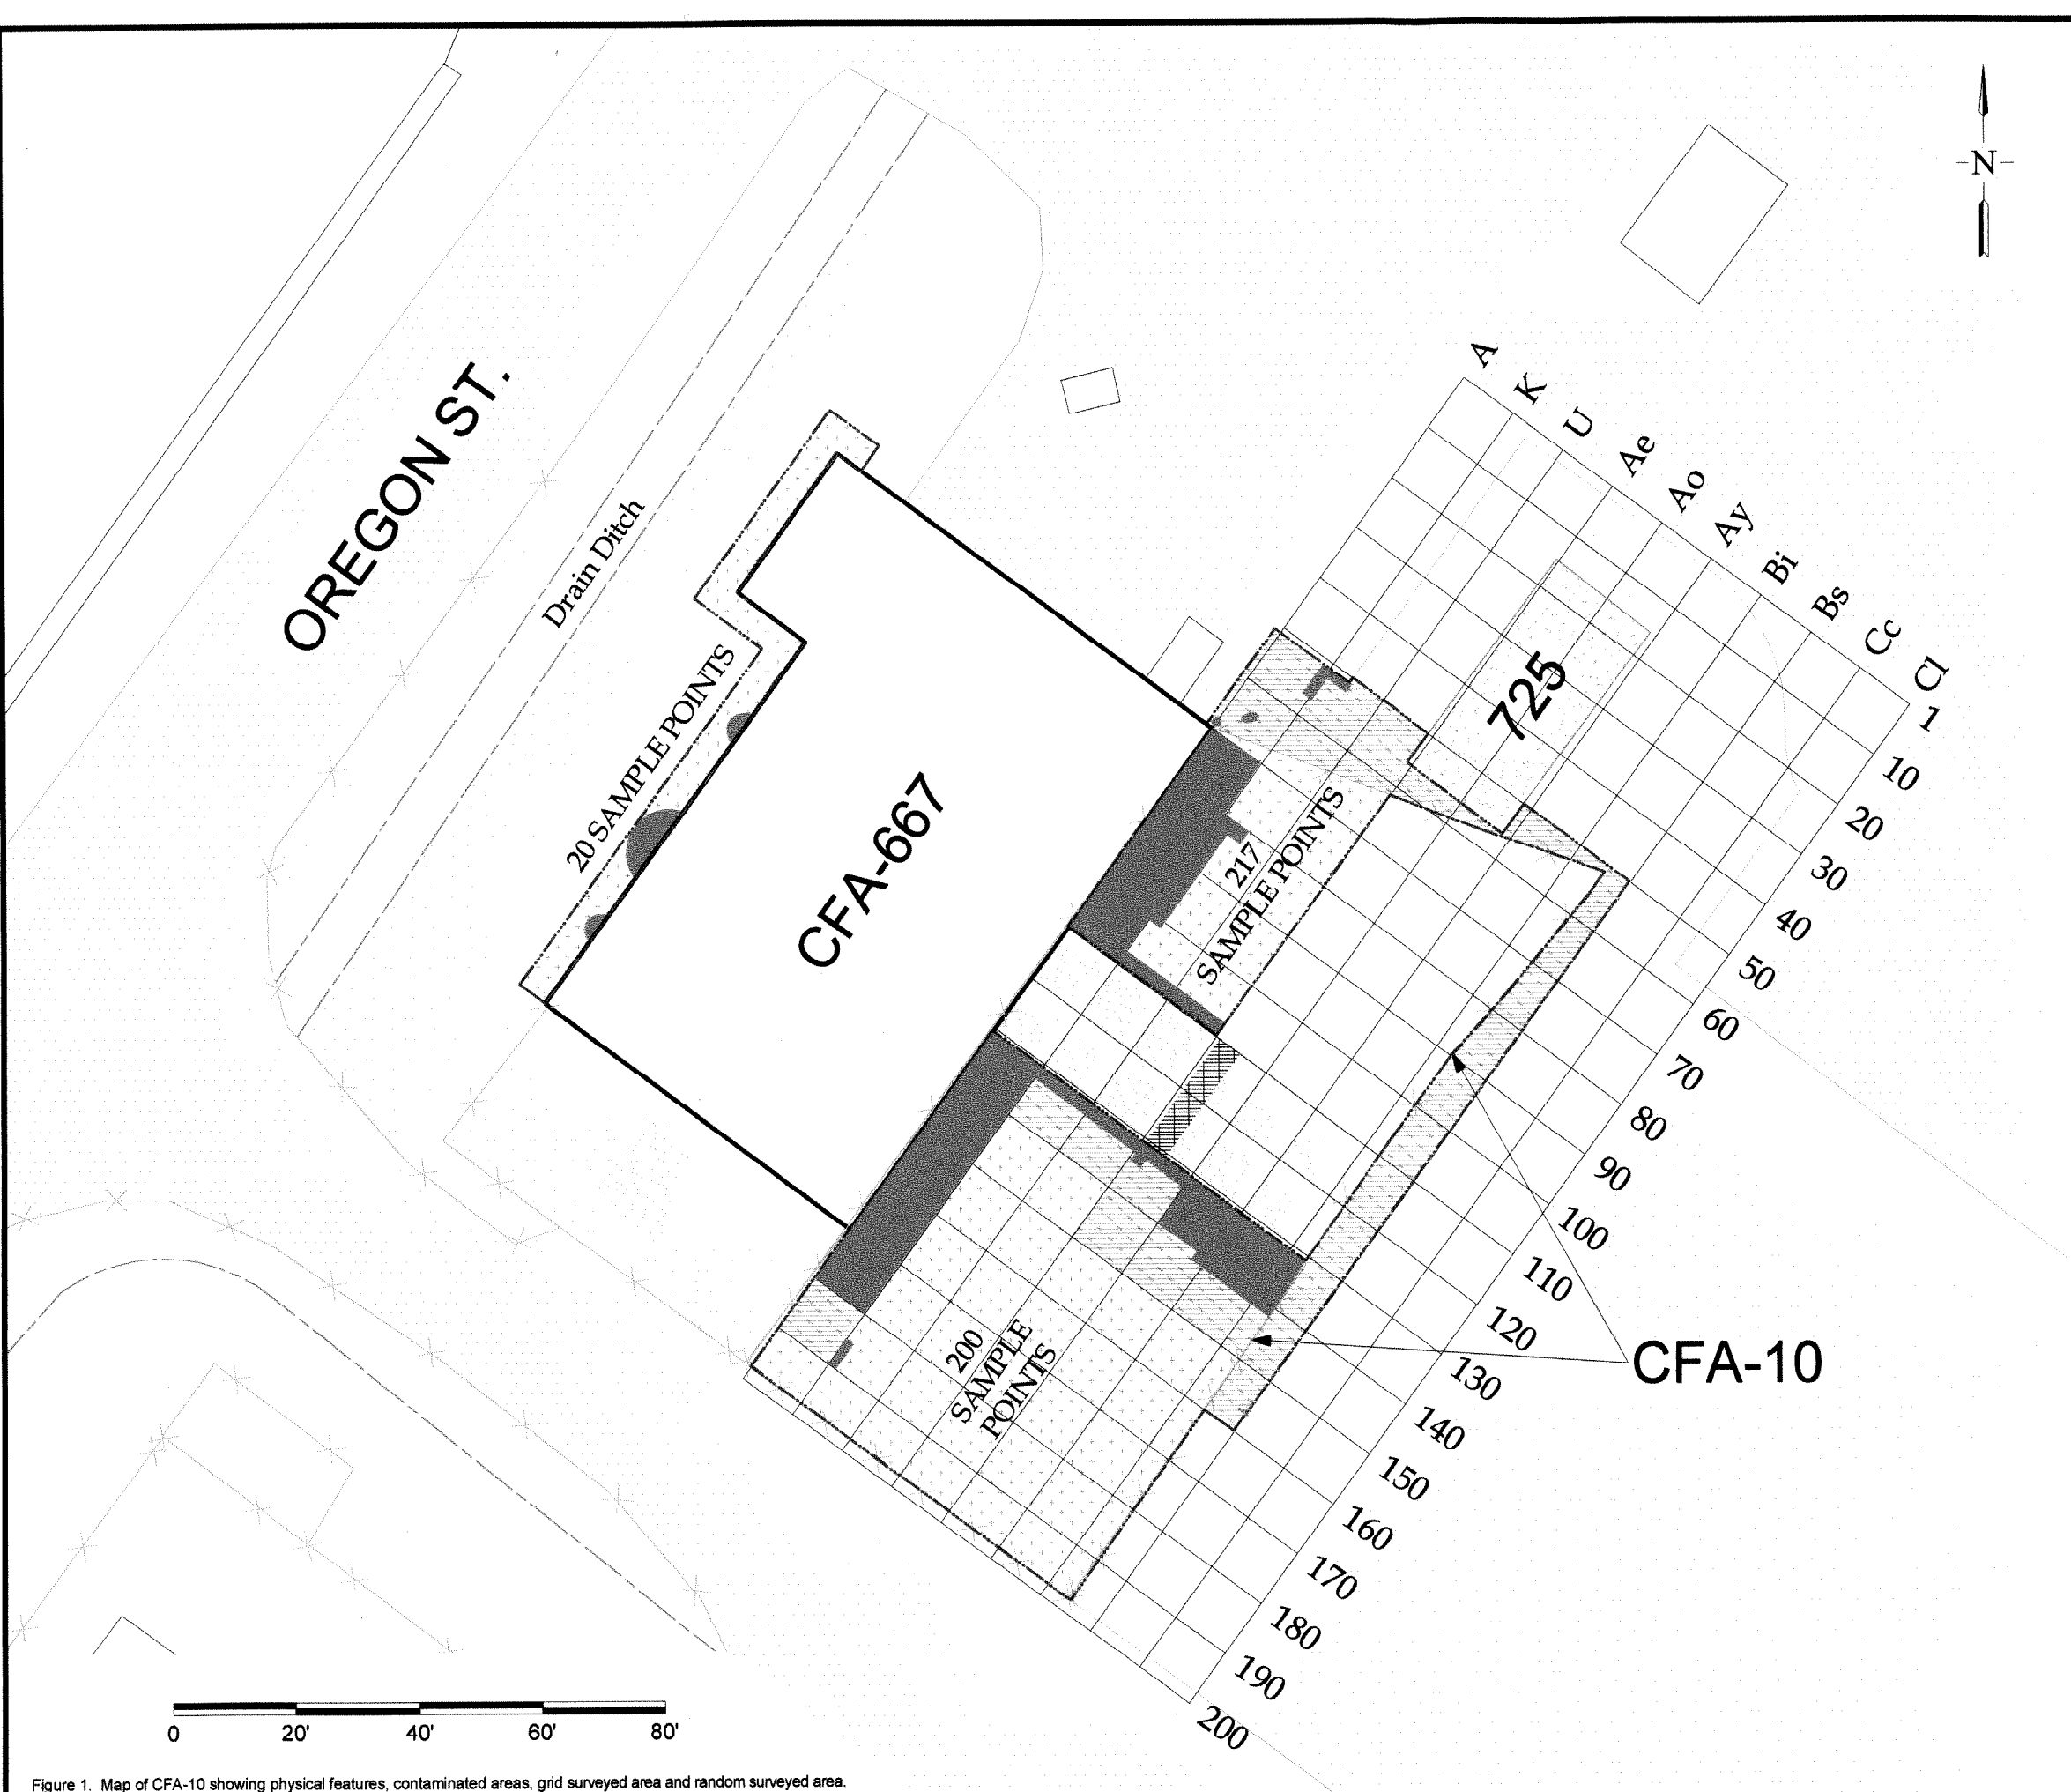
Figure 1. Map of CFA-10 showing physical features, contaminated areas, grid surveyed area and random surveyed area.

Surveys were begun adjacent to the outside of the fence on grid columns A—J, rows 61 to 70. Three areas of contaminated soil (> 400 mg/kg) were found in this grid. They were in locations B70, C62, and a region at E66, F64, and G65. Other areas within the grid were generally above the instrument detection limit for lead in the soil but levels were well below the 400 mg/kg PRG.

Along the building in columns A to J, the survey yielded unexpected results. Along the total length of the building, from the footing to about 9.0 ft away and in some places greater than 9.0 ft, lead concentrations were consistently found to be many times the PRG (Figure 12). There was very little evidence of visible surface lead in this area except immediately adjacent to the driveway.

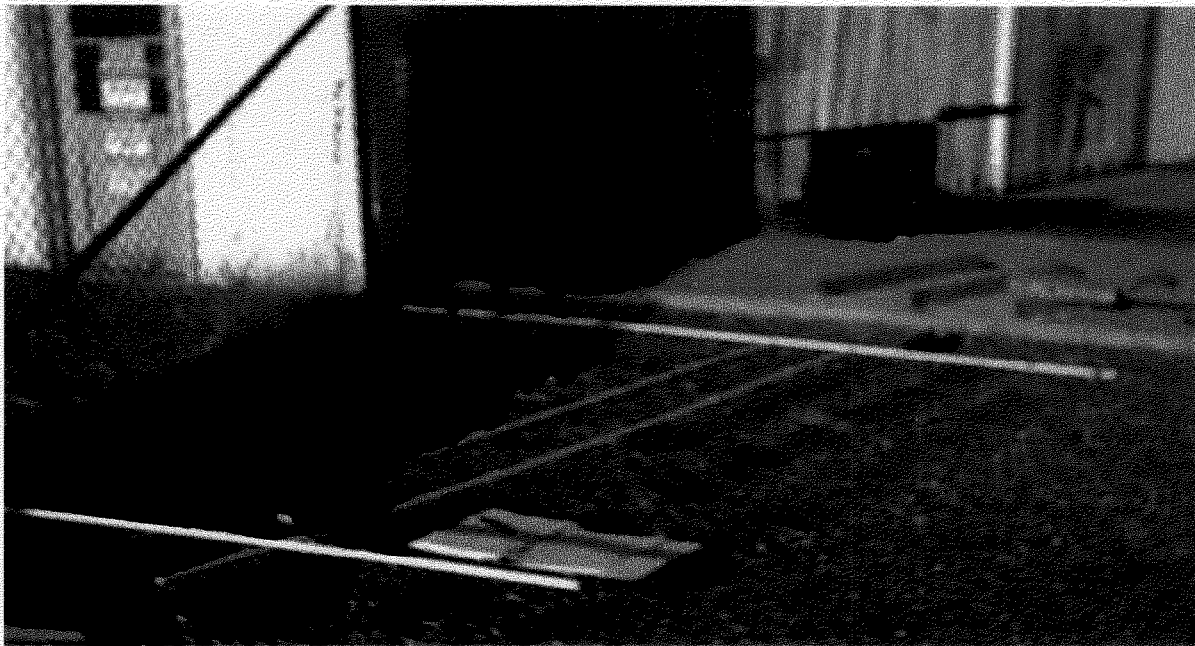
Surveys began on October 16, 2000. To obtain the required detection sensitivity, a measurement was obtainable in 6.0 seconds on the NITON instrument (2.0 Nom Sec-This correlated to 6.0 seconds of exposure time and instrument response evaluation electronics). Actual measurement time was to 6.0 Nom. Sec on the instrument, which correlated to approximately 20 seconds in count time. Taking measurements for this duration allowed for a more accurate reading. Note in Figure 2 that the surface rocks had to be scraped off to perform the XRF survey.

Figure 2. The northeast corner grid columns A—J, rows 61—70.

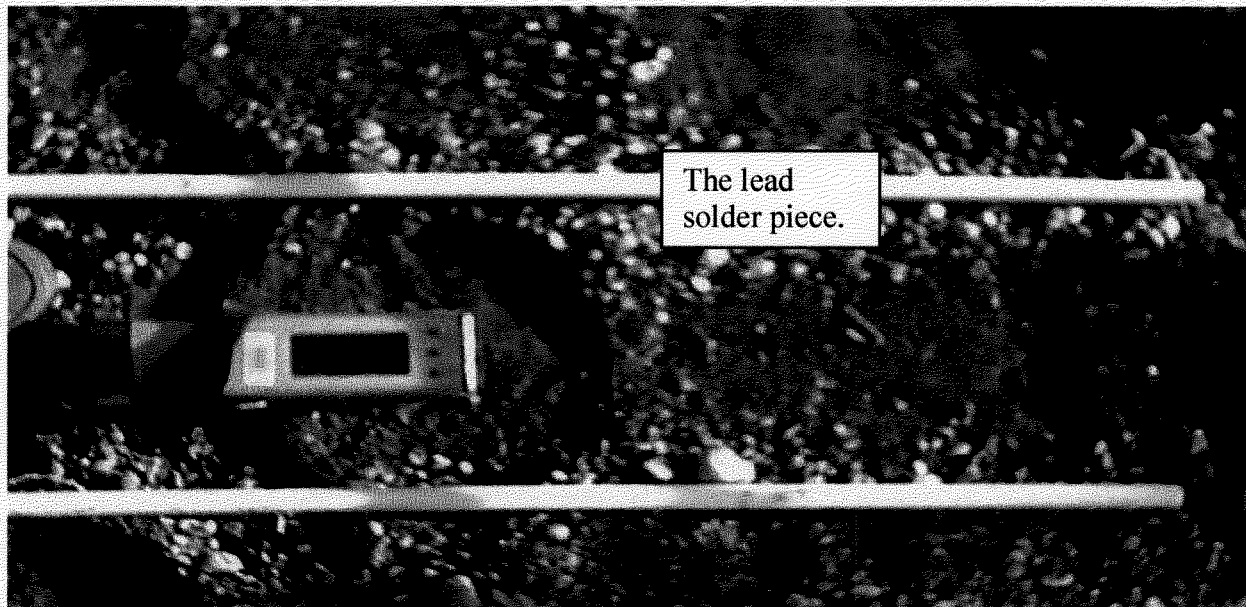
The next grid surveyed was columns K—T, rows 61 to 67. (The north fence angles to the north east.) Two interesting observations were noted during this part of the survey. There was evidence of scrap metals consistent with the types seen within the fenced area of the yard, and two lead items were discovered, a piece of lead solder and a buried lead spatter of fair size (see Figure 3).

Figure 3. Lead solder buried in the dirt.

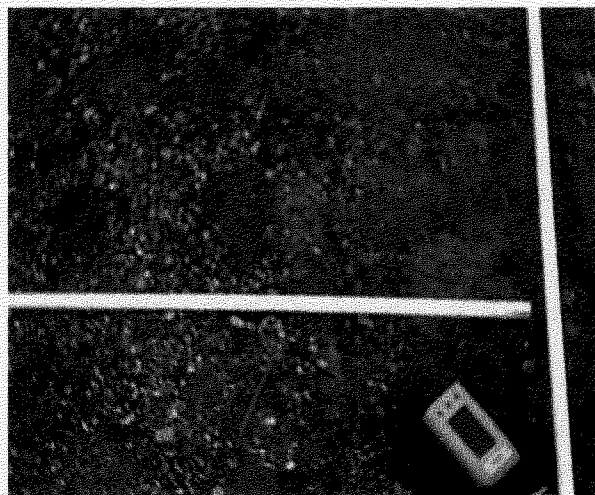
The completed survey of the north end identified high concentrations of lead in the columns H—K, rows 52 to 60 and at the site of N52. Close inspection identified that these were regions of apparent paint over spray (Figure 4). Many rocks in these areas exhibited yellow paint, which matched in shade and gloss the paint on a power pole tensioning cable cover (Figure 5).

Figure 4. Yellow paint overspray on rocks.

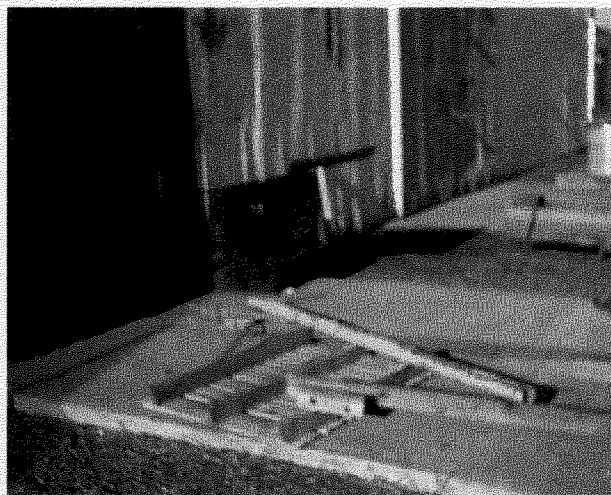
Figure 5. Yellow painted cable guard.

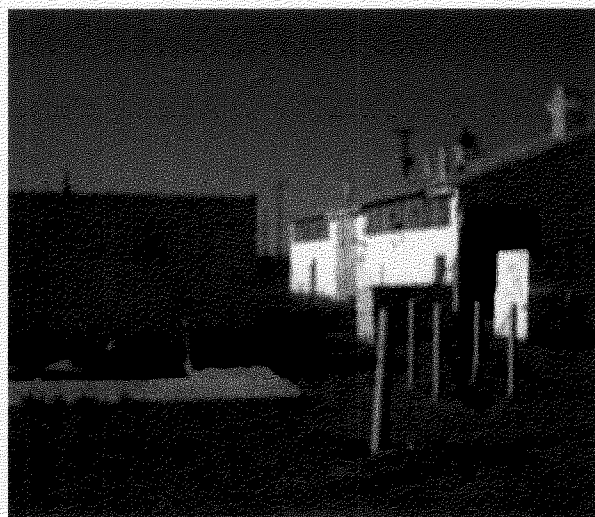
The other observation is that the north fence does not match the remaining yard fence. The south edge of the footing of the removed building may have been aligned with the north fence of the yard at some time (Figure 6). This would explain the presence of waste metals and solder in the soil outside of the existing fence boundary. Another source of lead contamination was identified in the form of yellow paint chips present in some areas. These paint chips, when segregated and analyzed separately, were found to be high in lead concentrations.

Figure 6. The northern edge of the grid.
Removed building slab shown.

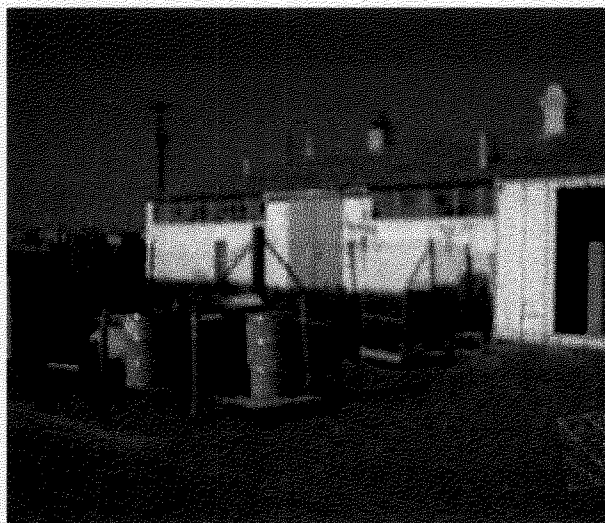
Figure 7. Northeast corner of the fence, paint chips in this area.

Paint chips were identified between the fence and south part of the slab and also in the area of the forklift man basket shown in Figure 7. The yard east of the fence is used for heavy equipment temporary parking. On the day of the survey, a Fruehoff trailer with peeling yellow paint was noted. The paint chips are a different gloss and shade than the paint over spray on the rocks. The areas north of grid row 51 were not surveyed because they were either asphalt or in an area of disturbed surface. Also, columns U—Ad in rows 51 to 60 were all less than detectable on the NITON instrument. This indicates that the extent of the contamination had been reached.

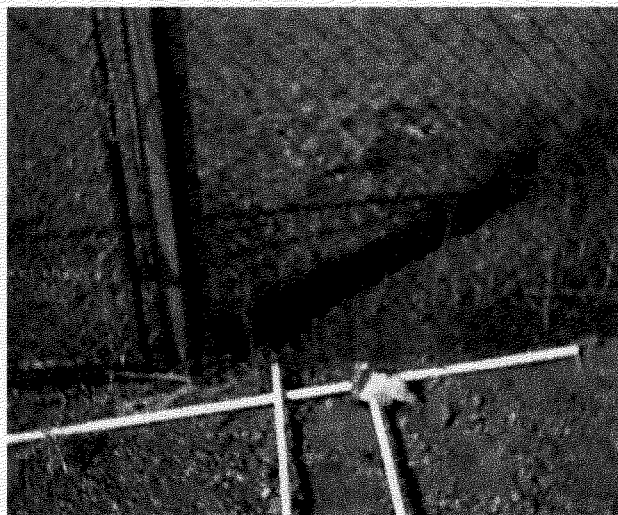
Surveys along the east edge of the fence identified two things. First, soils contiguous to the fence do not contain elevated levels of lead above the proposed remediation goal. However, there are rocks in this area with yellow paint that are also high in lead concentrations. Second, one piece of lead was found outside of the fence partially buried in the soil (Figure 8). Soil beneath this piece of lead was high in lead content. The middle gate shows evidence of an object being painted with a similar high gloss yellow paint (Figure 9). It is assumed that grading of the parking lot for weed control has spread the rocks to the

Figure 8. Lead partially buried at grid Bn72.

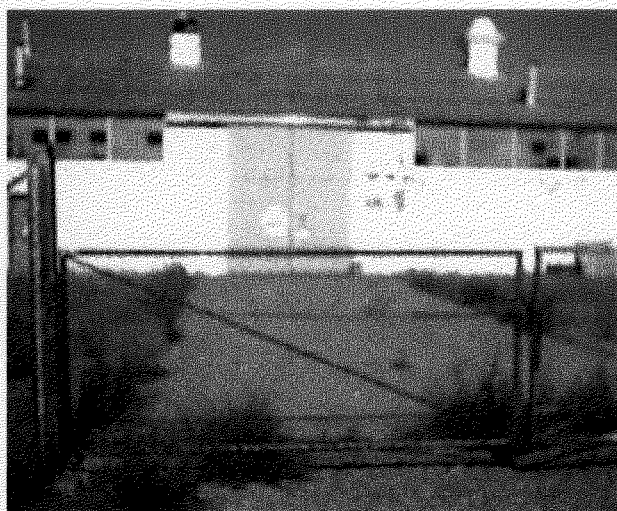
north along the fence. There is evidence of grading and also an absence of yellow rocks to the south of the middle gate, which supports this assumption.

Figure 9. Yellow paint on right-hand gate.

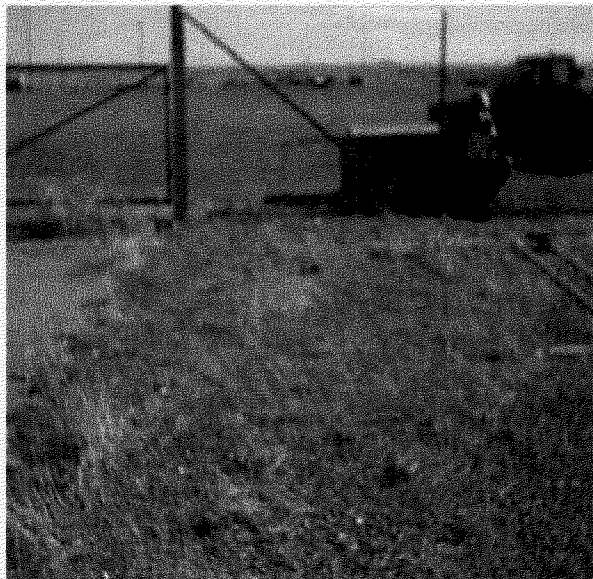
The area from columns Ae to Bm and rows 131 to 144 (Figure 10) has a high concentration of visible lead metals. There are also areas with gray paint and yellow paint overspray on rocks. Because of the high concentrations of visible lead metals, these areas were not 100% surveyed. However, near to the lead as shown in Figure 11 the levels can still be less than 400 mg/kg. The readings near the lead in Bh141 and Bh142 (shown) were 628 and 520 mg /kg. One foot away the levels were less than 200 mg/kg in all directions. The measurements made at grid locations along the driveway from the grate to the building were consistently higher than the PRG. It was thought that the ditch might be more highly contaminated because of drainage, which did not turn out to be the case for surface soils. Measurements of surface soils under the grate ranged from 135 to 326 mg/kg. There is a large crack at the driveway to grate interface that may have high levels of lead in it, but the area was not accessible for survey.

Figure 10. Area of concentrated surface lead.

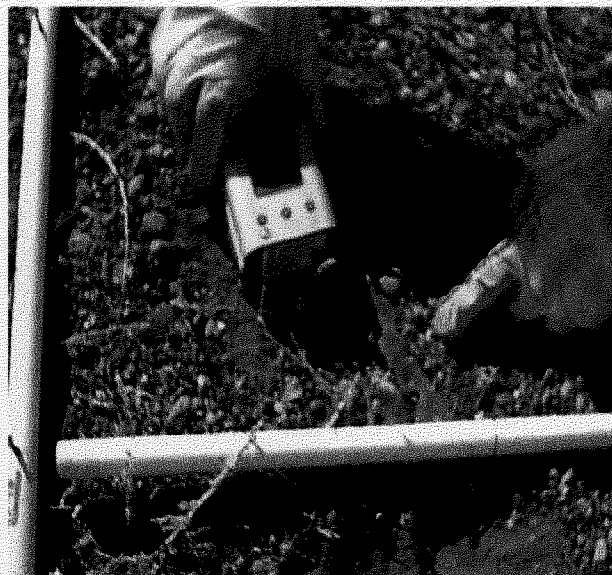
Figure 11. Bh142 520 mg/kg near surface lead.

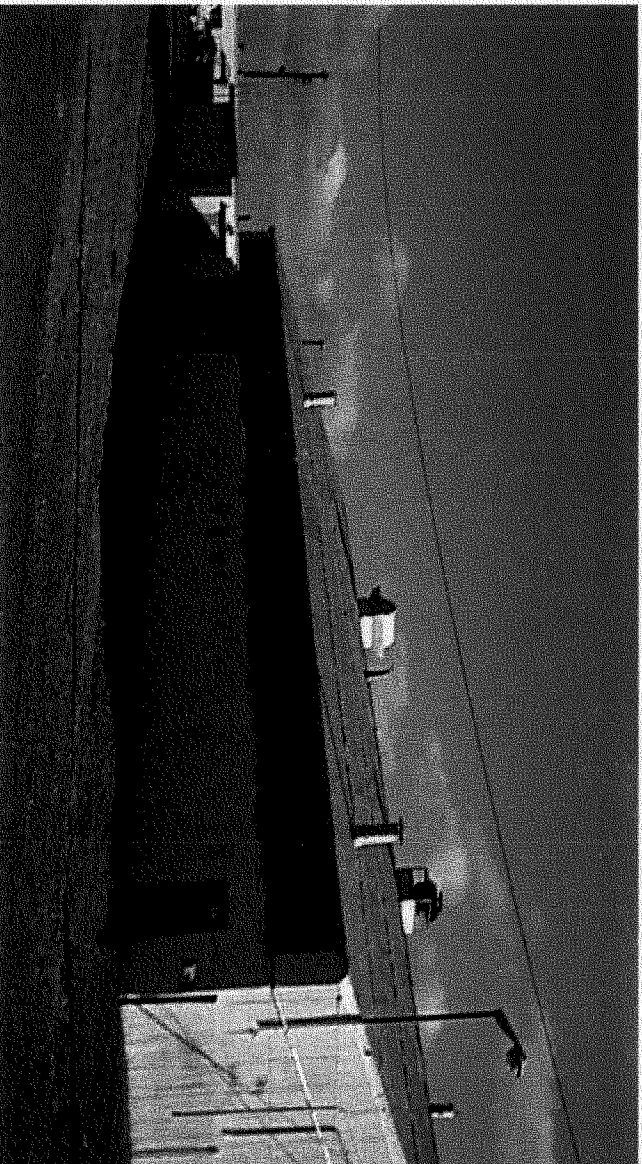
After determining the concentrations along the east side of the building it was thought that there might be a need to evaluate areas on the west side of the building. Twenty survey points were randomly selected along the west side of the building. Survey locations were measured using the southwest building corner as a reference location (Figure 13). Eighteen feet from the southwest corner and 1.0 ft from the building, a measurement of 478 mg/kg was recorded. At 30 ft from the southwest corner of the building and 1.0 ft from the building, the reading was 345 mg/kg. At 35 ft from the southwest corner of the building and 4.0 ft from the building, the reading was 691 mg/kg. At 58 ft from the southwest corner of the building and 4.0 ft from the building, the reading was 1,130 mg/kg.

Figure 13. CFA-667 west side, note the roof ventilators.
